Mianus River Cold Water Habitat Improvement Project

Town of Stamford, CT

Trout Unlimited, Inc.

May 20, 2020

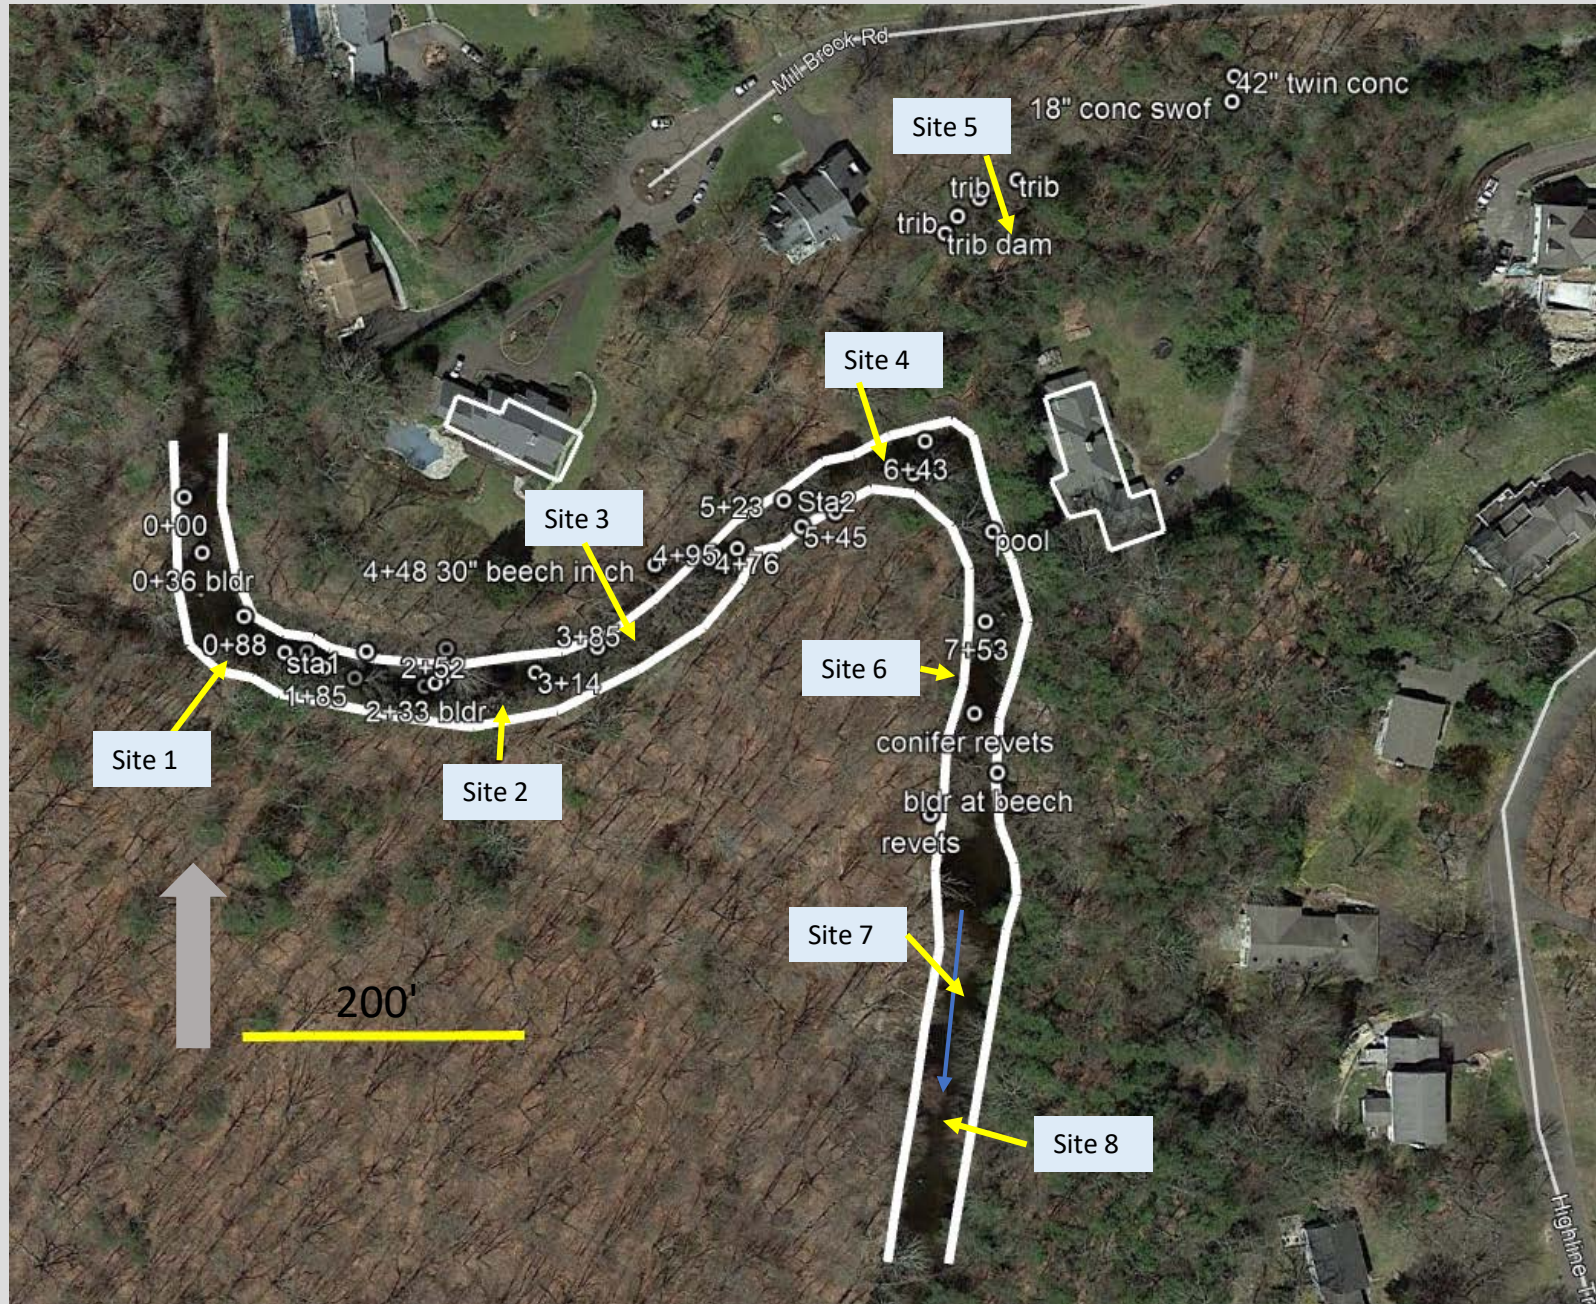
Mianus River Project Restoration Plan

Aerial Survey
Plan View

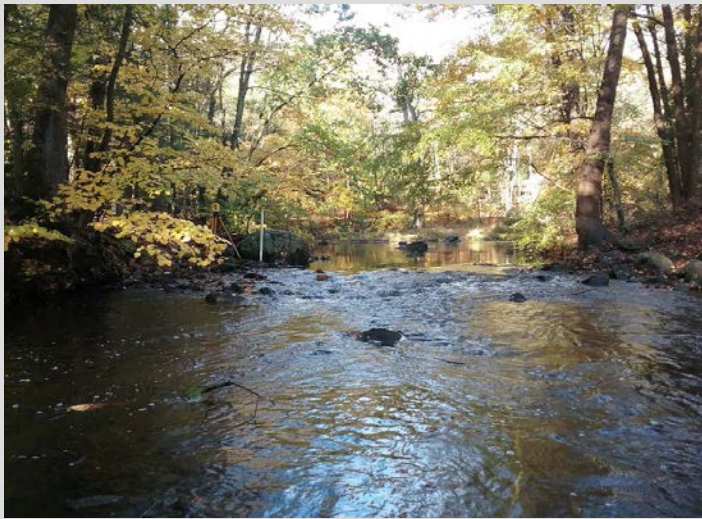
Site 1 Bed and Bank Ballasted Logs

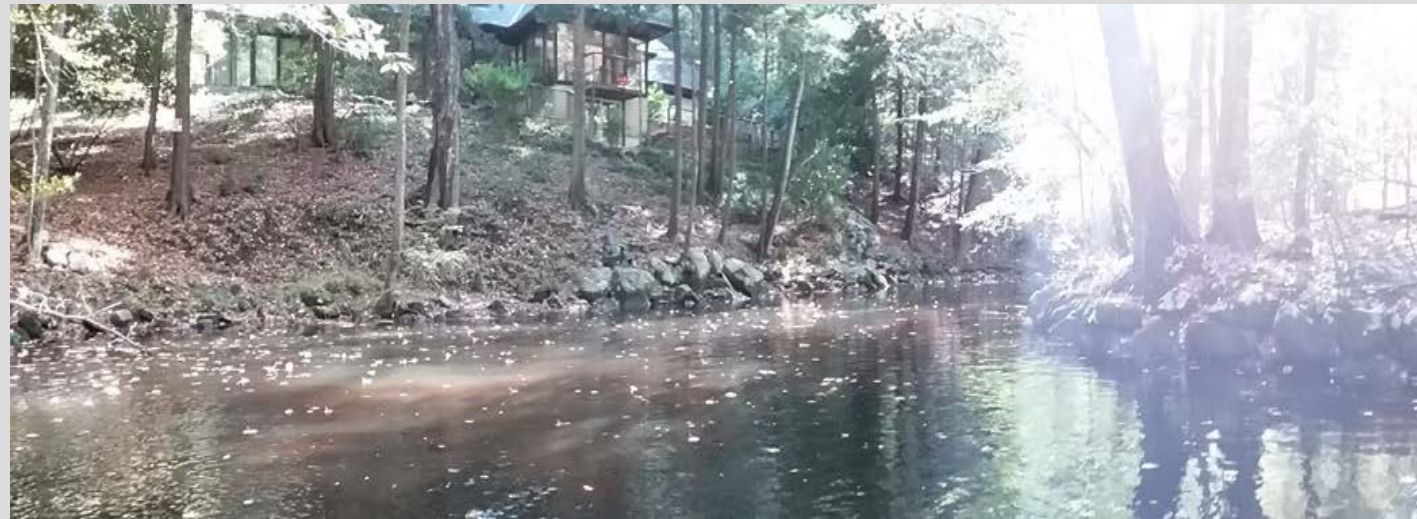
Site 4 Bed and Bank Ballasted Logs

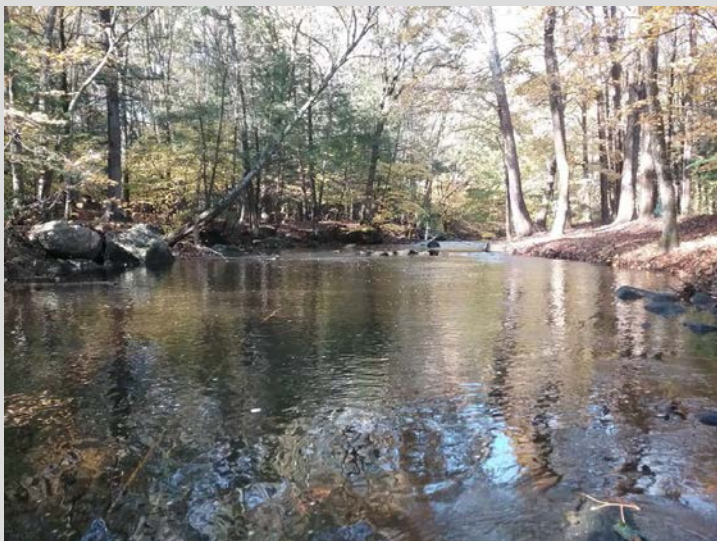
Site 2 Bed and Bank Ballasted Logs

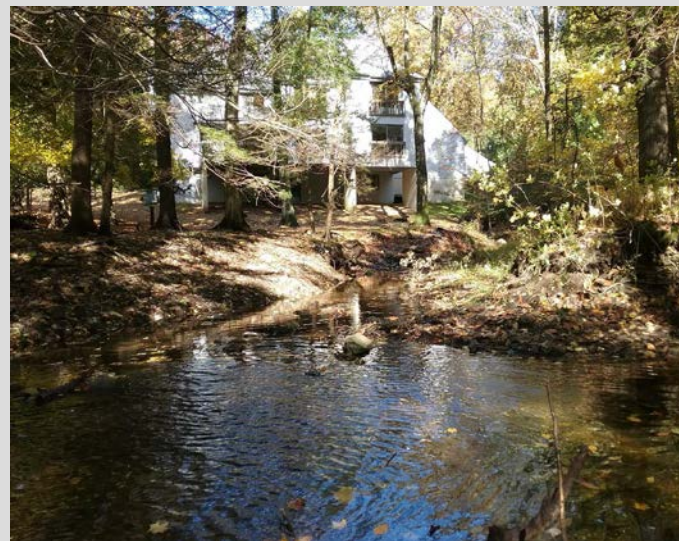
Site 5 Tributary Log Vanes

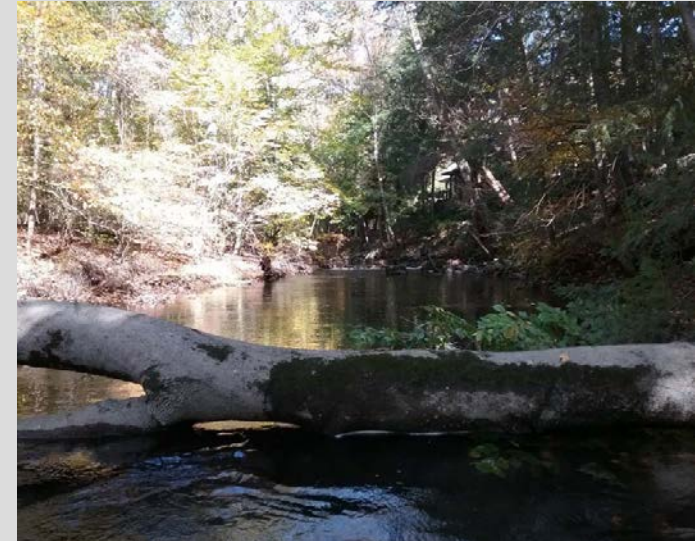
Site 7 Boulder Cluster

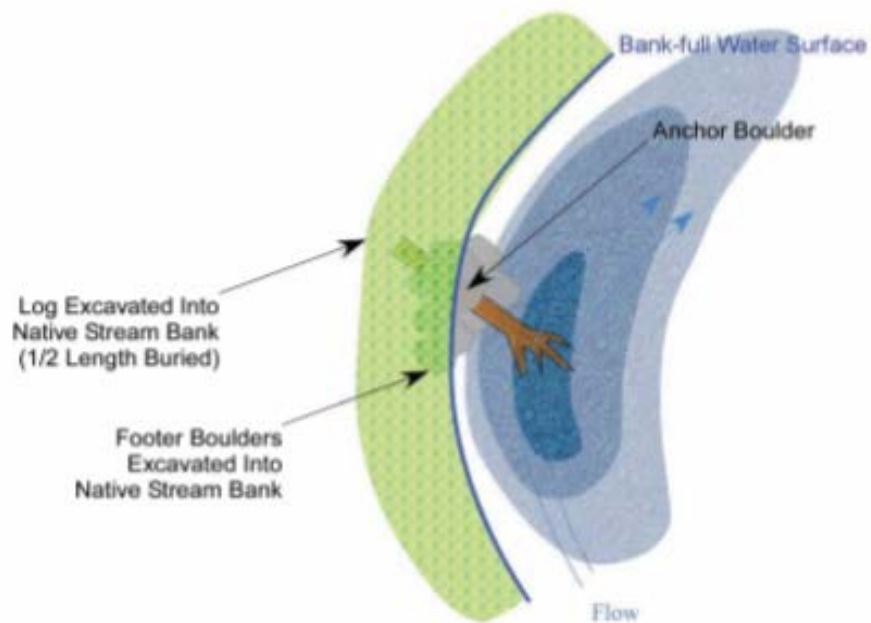
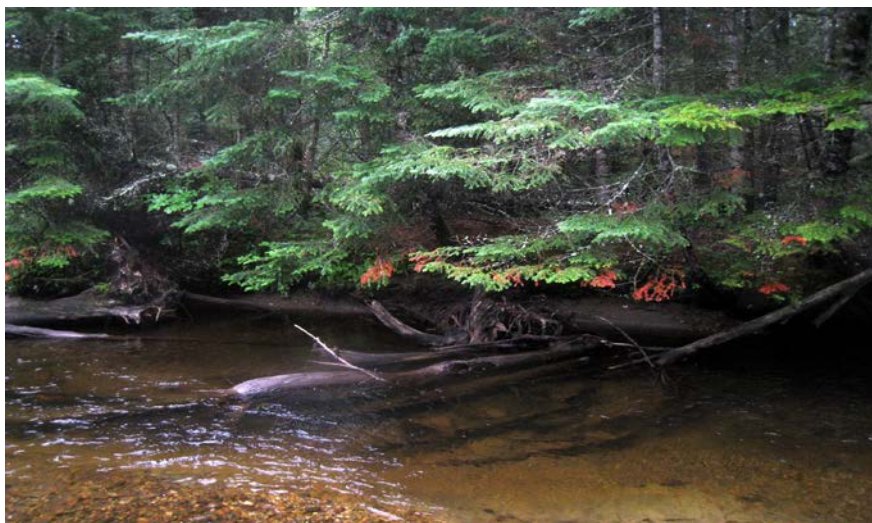
Ballasted Bank and Bed Log Treatment Typical

Typical design developed by TroutScapes River Restoration, LLC.

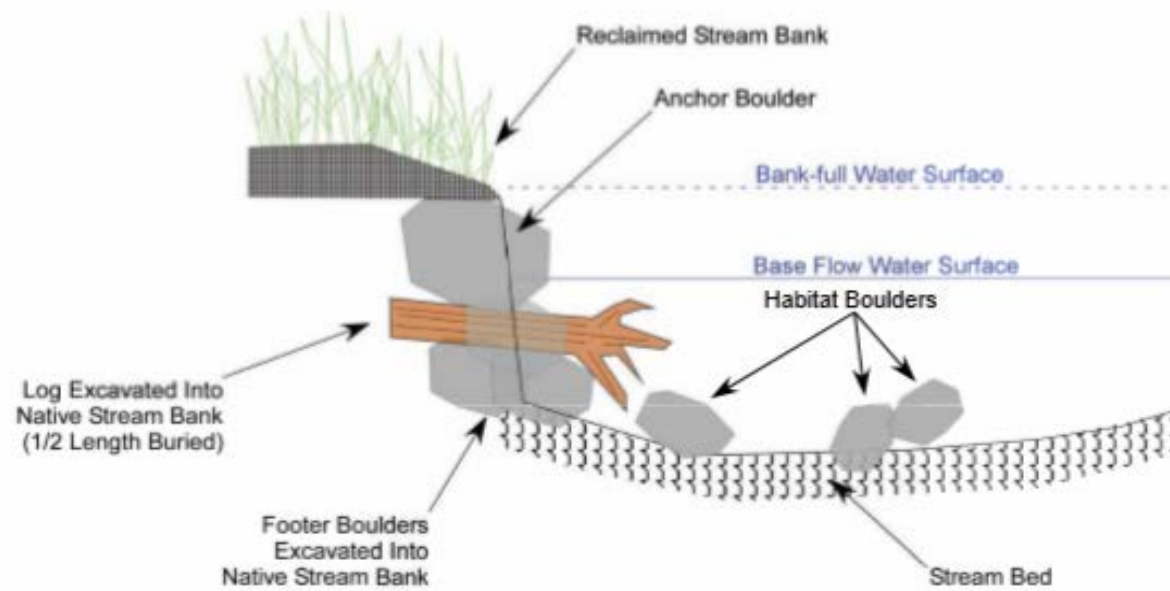
Natural wood debris filled pool.

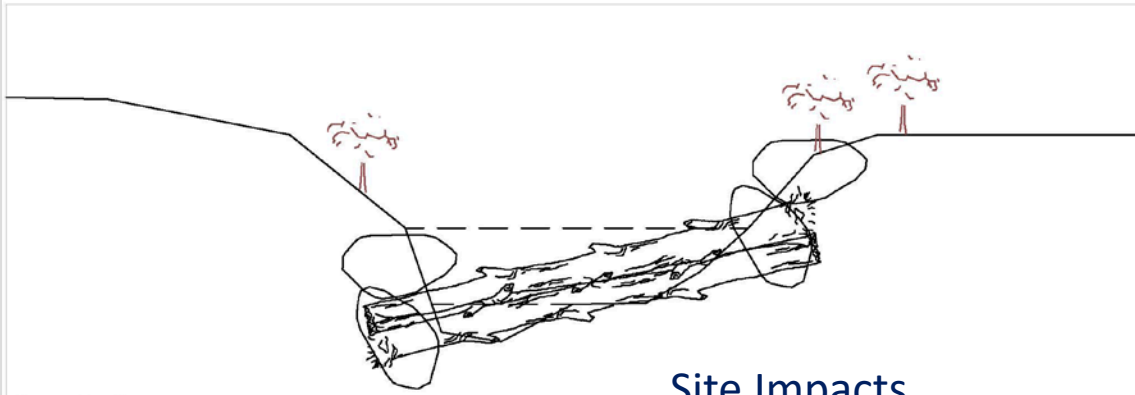
Log Vane Treatment Typical

Flow

Profile

Cross Section
